# Oxford Diocesan Guild of Church Bellringers

### Technical Note No. TBC04 – Issue 1

#### CLAPPER BUSH WEAR

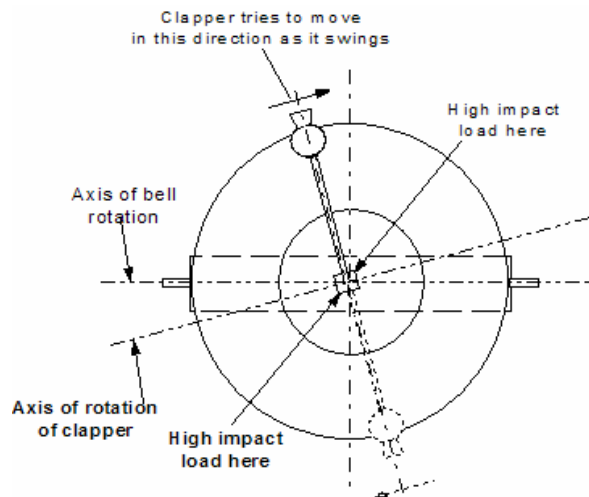
**Fig.5**  
**Plan - Bell Up**  
**Clapper Mis-aligned**

If the clapper becomes misaligned in the bell it will try to swing in the same plane as the bell.

As a result the bush is twisted against the pivot pin and high impact loads are generated at opposite ends of the bush as the clapper strikes. See Fig.5.

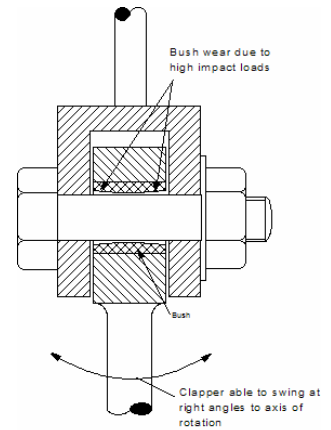
Fig.6  
Section Through Clapper Head  
and Independent Crown Staple  
Worn Bush

Over a period of time the bush material breaks down where it is subject to repeated high impact load so that eventually the clapper can swing from side to side. See Fig.6

If not corrected, the bush will wear through and the pivot pin will be in direct contact with the metal of the clapper. This will result in the hole in the clapper head becoming oval, making the eventual re-bushing more difficult and expensive. It will also damage the pivot pin which may have to be replaced.

If the clapper can be moved more than 1 centimetre either side of the vertical then this is an indication that the bush is worn. Significantly more than this would indicate that the clapper should be re-bushed.
