# Oxford Diocesan Guild of Church Bellringers

### Technical Note No. TBC04 – Issue 1

#### CLAPPER BUSH WEAR

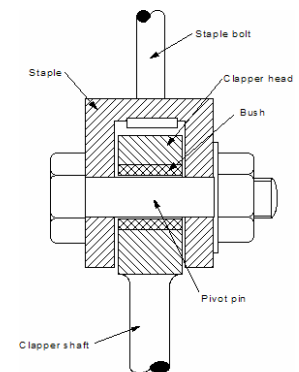
Fig.2  
Section Through Clapper Head and Independent Crown Staple Un-worn Bush

To prevent the hole in the clapper head wearing as the clapper swings to and fro it is lined with a sacrificial bush, designed to wear and be replaced at regular intervals.

The bush, irrespective of the material from which it is made, is a forced fit in the hole in the clapper head and is a close fit to the pivot pin. The whole assembly is intended to

transfer the forces evenly along the length of the bush from the swinging clapper to the pivot pin.

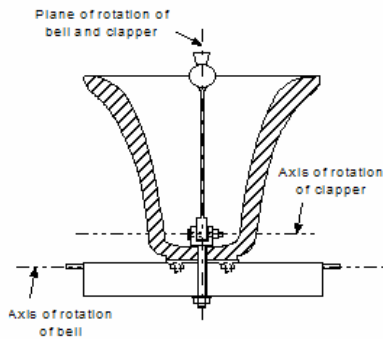
**Fig.3**  
**Section Through Raised Bell**  
**Clapper Correctly Aligned**

To ensure that the minimum force is transmitted through the bush the clapper must be aligned in the bell to swing in the same plane in which the bell rotates, see Figs. 3 & 4.

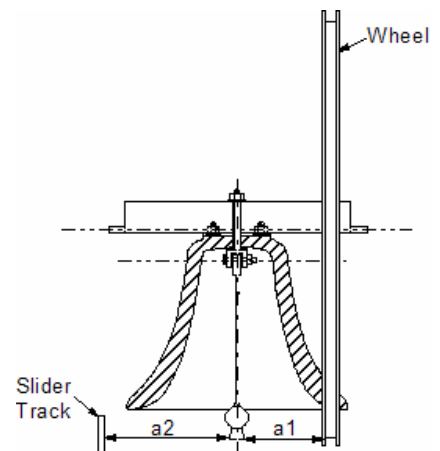
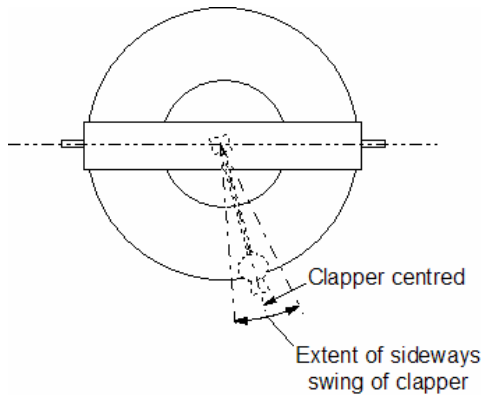
With the clapper hanging vertically in the bell measure the shortest distance from the ball to the chosen datum using a pair of callipers or a locking tape measure. It may be easier to measure from a distinct point on the clapper flight. Make a note of measurement  $a1$  if using the wheel, or measurement  $a2$  if using the slider track (see diagram).

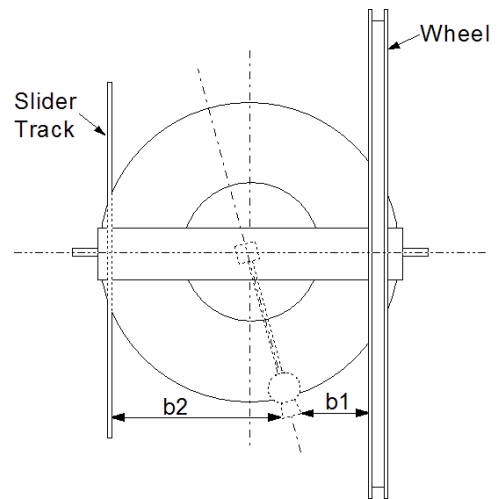
Pull the clapper so that it touches the soundbow. Swing the clapper to the left and note the extent of the movement along the soundbow. Swing the clapper to the right and then position the clapper so that it is centred at the mid point between the two points marking the extent of the swing (see diagram).

Holding the clapper in this position and using the same point on the clapper, measure the distance to the same datum. Make a note of measurement  $b1$ , or measurement  $b2$  (see diagram).

Calculate the difference between  $a1$  and  $b1$ , or  $a2$  and  $b2$ . If the two measurements differ by more than 6 to 8 millimetres then the clapper needs to be re-aligned.

Pull the clapper against the soundbow and move it sideways in the direction that reduces the difference between the two measurements. If measurement  $b1$  is less than  $a1$  move the clapper away from the datum; if  $b1$  is greater than  $a1$  move the clapper towards the datum. Repeat the measurements, remembering to centre the bush wear as before, and adjustment until the difference in the two measurements is as close to zero as practicable.

Recheck the centring and measurements and if there has been movement repeat the adjustment process. If there is no change complete tightening the nut using the tightening procedure above. To prevent the staple nut working loose do not forget to replace and tighten the lock nut or replace the split pin.
